Water Quality Research and Monitoring Program

Fiscal Year FY11
Annual Report
July 1, 2010 – June 30, 2011
City of Santa Barbara

Creeks Division
10/31/11

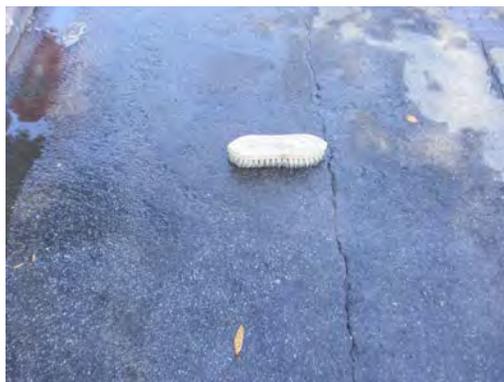
De La Vina 24 hrs:

As expected, MBAS tests for anionic surfactants were not associated with fresh slurry seals. The MBAS criteria for Central Coast inland surface waters, enclosed bays, and estuaries according to the Basin Plan is 0.2 mg/L (CCRWQCB, 1994); most of the samples exceeded this standard, including the control tests. Samples were collected to be tested for cationic surfactants, but not tested. Cationic surfactants were not tested; however, the foaming that was present after the slurry seal was applied could originate from the cationic surfactants. The pictures below demonstrate the foaming present after the slurry seal was applied compared to the control:

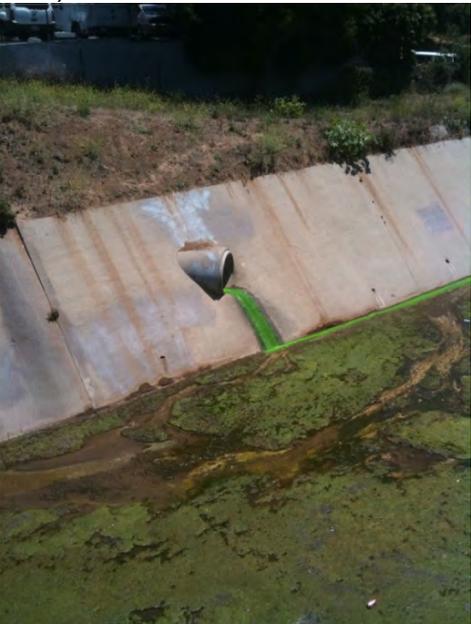
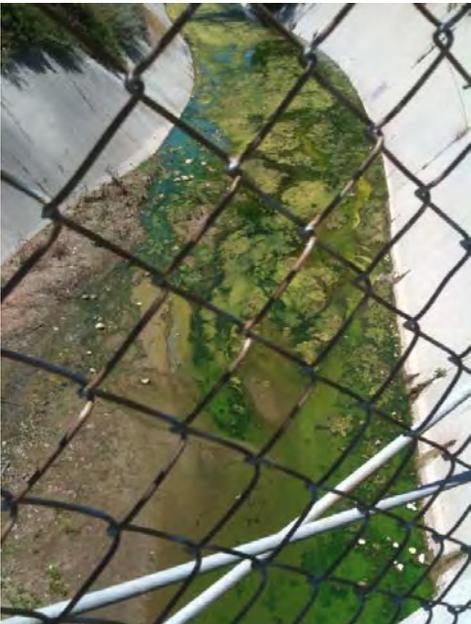
Jim put the rhodamine probe in the manhole at Bath. Three colors of dye were used in the three different buildings on that property. Each building is on its own lateral (Jim talked to brand new property owner – happened to be on site). SpudNuts and five other toilets in that building had green dye (probably flourescein). After putting in the dye, Cameron and Jim went down to the creek and saw this (left is drain, right is Canon Perdido an hour or so later):

WW immediately sandbagged the drain and started pumping the sewage to a vactor. A repair was made, but it might be only a 5' sleeve. Tim thinks we should dye test again. Manual said they would flush it from De La Vina to Bath. No beach warnings during this period.

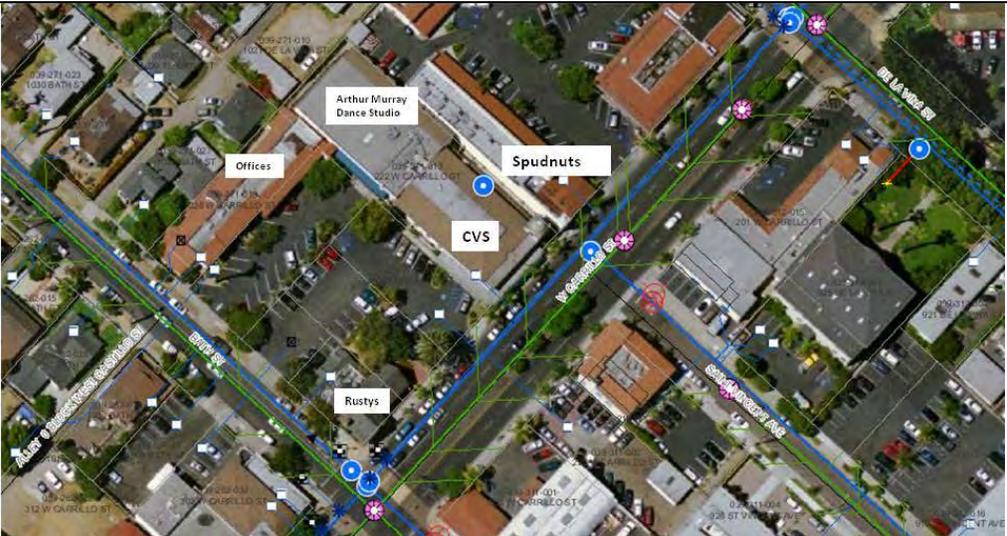
Leak 182.

<p>Weds. 7/6/11</p>	<p>From JR conversation with MR. Lateral was connected four feet down the line from the manhole. Was a leak. The reason we weren't seeing solids was because there was a pocket that had a dam, so water was spilling over. They did find the Y (where it enters the sewer main). Require lateral upgrade to 6' pipe by August. They called EHS and OES.</p> <p>Jim and Jill to Greyhound –</p> <ul style="list-style-type: none"> - Upon arrival, noted that curb drain on Carrillo was wet. Sampled that water. Very stinky (ammonia?). Talked to guy sweeping lot, in Spanish, and I think he said that he washes the parking lot every third day with "Pinol." I think he said that the area is used as a bathroom. We took photos of this outlet. <p>My estimate of sewage outfall from Spudnuts was ~1,000/day (8 hours a day, 2 gpm based on Jim's measurement).</p>	<p>Ammonia: Greyhound drains to Carrillo (pooled): 13.2/mg/L Chapala (flushed): 54.9 mg/L</p>
